Sustainable Drainage and Pond Creation: Melrose Golf Club

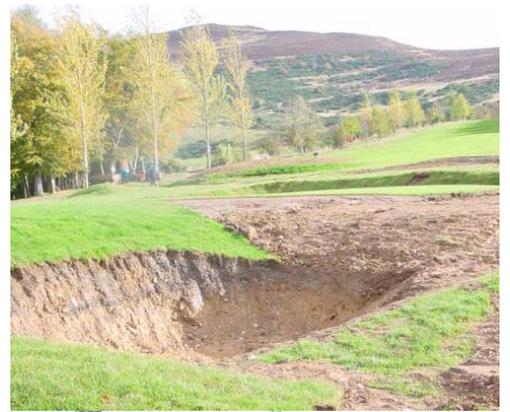
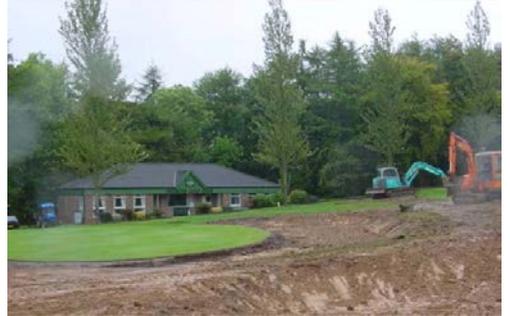
During construction

Spoil from excavation of the ditches and the ponds was deposited elsewhere in the course encouraging runoff from, rather than onto, playing areas. Rough and out of play vegetation was increased and plants and trees were purchased to create additional habitats around the new water features.

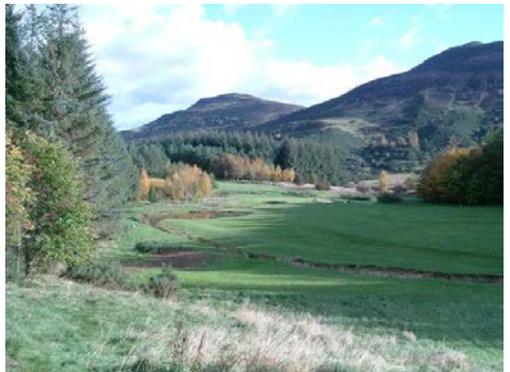
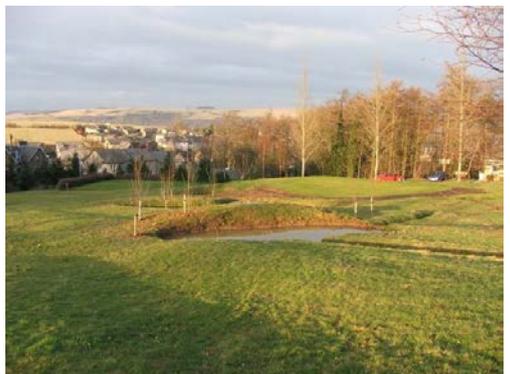
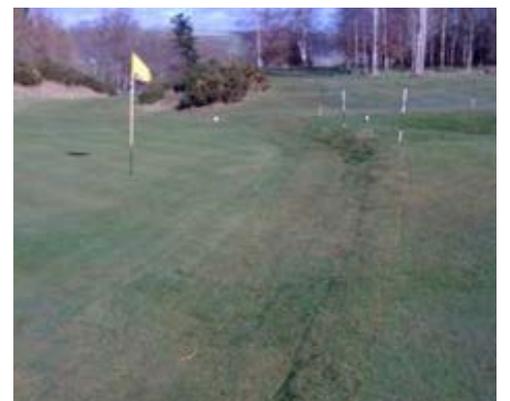
Post construction – ponds and swale

In conjunction with the Scottish Golf Environment Group, Melrose embarked on a programme of sustainable drainage across the course. This consisted of changes to mowing regimes increasing rough, turf aeration and other cultural agronomic techniques alongside the construction of a network of swales, open drainage ditches, and retention and detention ponds.
