St Andrews Links Trust: Coastal Erosion and Dune Repair

The Eden Estuary Project

West Sands Dune Restoration Project

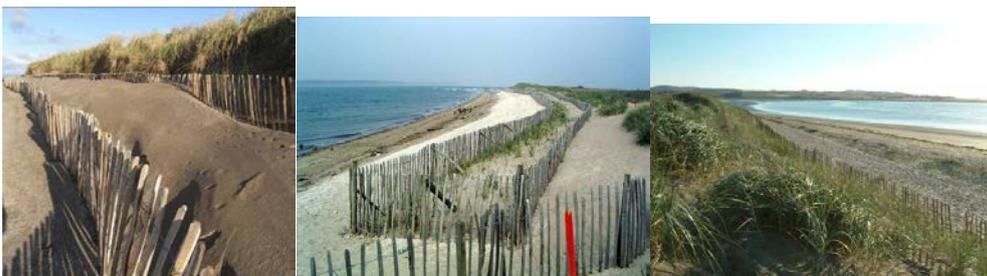
Sand Recharge area

This was followed further along the coastline with a revised approach; sand recharge. This beach nourishment project buried the installed gabions and built a new 300 metre dune along the remaining soft dune system to the north of the new gabions. Sand was excavated from a part of the sand flats to the north and transported to the dunes by low ground pressure trucks, it was then shaped by bulldozers. These sand flats have been steadily growing in size over the past 20 years. The Environmental Impact Assessment (EIA) process ensured that mitigation measures were put in place so there was no significant disturbance to the breeding bird sites, mudflats, sand flat, sand dune and saltmarsh habitats and the common seals that visit the estuary and bask on the sand banks at low tide. Permission for further sand recharge work was given in 2008 to ensure the area continues to be effective in combating the dune erosion.

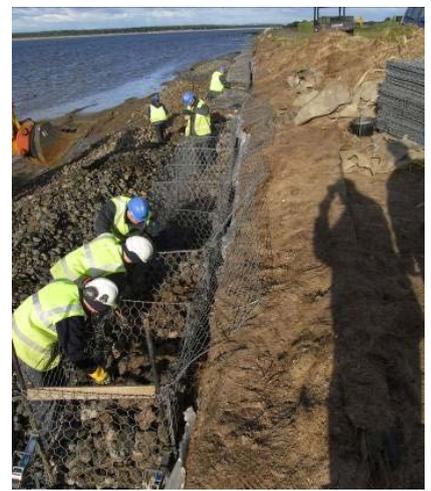
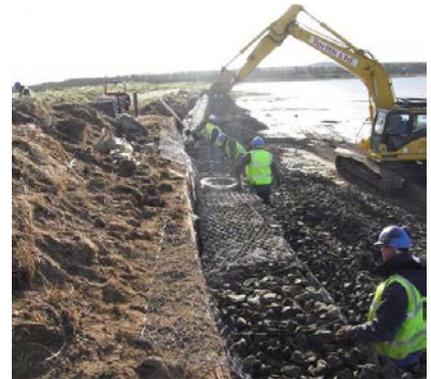
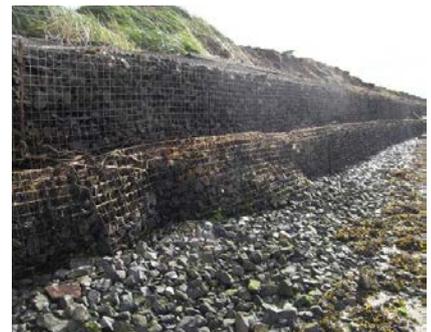
Gabion Basket construction

In 2001, 100 metres of hard defences were constructed along the eroding dunes at the end of the Jubilee course. This consisted of a line of contoured sloping gabions, which are large metal baskets filled with rocks. These stabilise the dunes and stop the sand from being eroded away by absorbing the energy of the incoming sea.

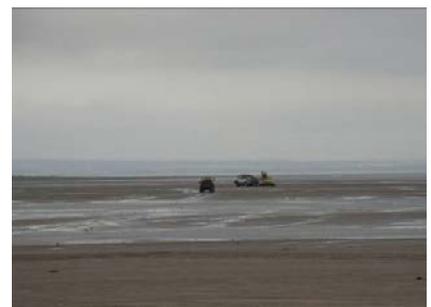
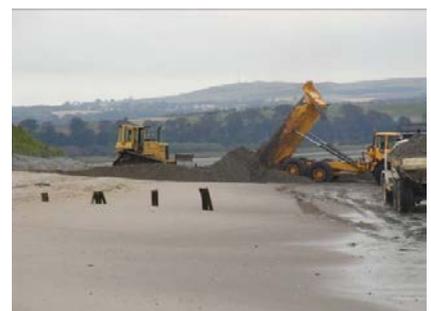
Sand excavation from the estuary

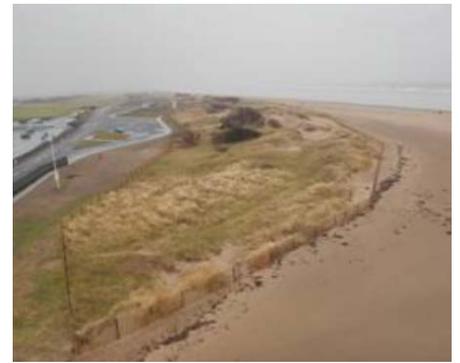
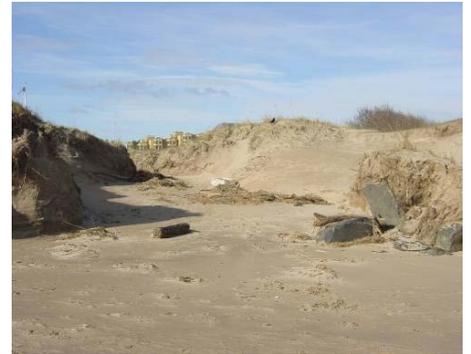
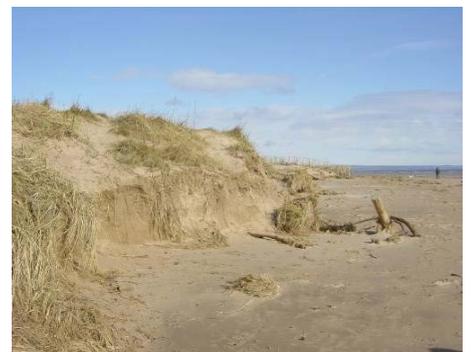
Natural processes combined with a storm in March 2010 caused extensive erosion to portions of the ancient dune system at the West Sands. To restore the section at the Swilken Burn to its original form, Scottish Natural Heritage permitted the removal of sand from a site off Out Head but only until the end of April 2010 to avoid the potential for disturbance to wildlife, especially seals. The contractors had only about five hours to excavate the sand each day and a convoy of six huge dump trucks, hauled 14,000 tons of sand from one end of the West Sands to the other.

Storm damage to the West Sands dunes March 2010

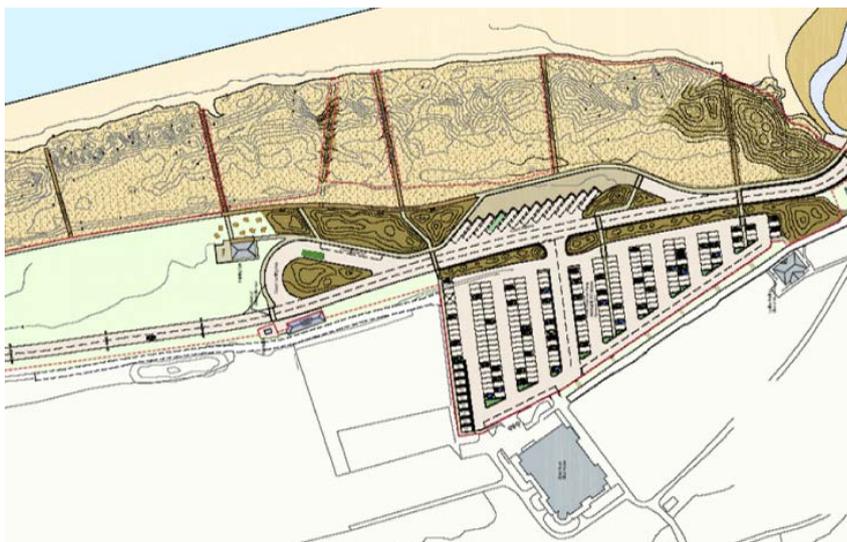
Site of Dune Restoration Project

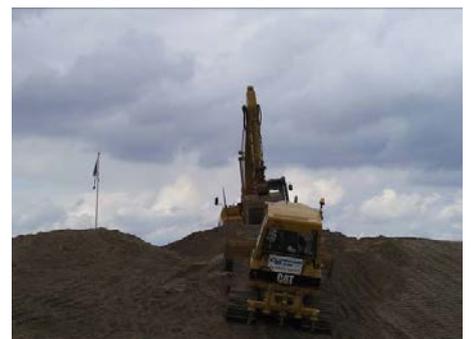
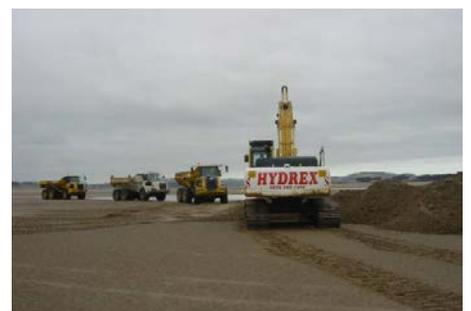
Sand excavation and haulage

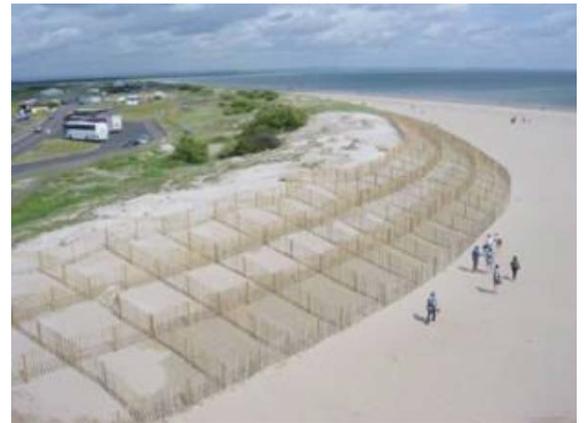
July 2010 - Dunes taken after restoration

Jute matting and chespaie fences were installed to stabilise the dune until vegetation was fully established. The planting was done by many volunteers including staff of Fife Coast and Countryside Trust, St Andrews Links Trust, BT, BTCV, students from St Andrews University and Elmwood College and ECOS Countryside Services.

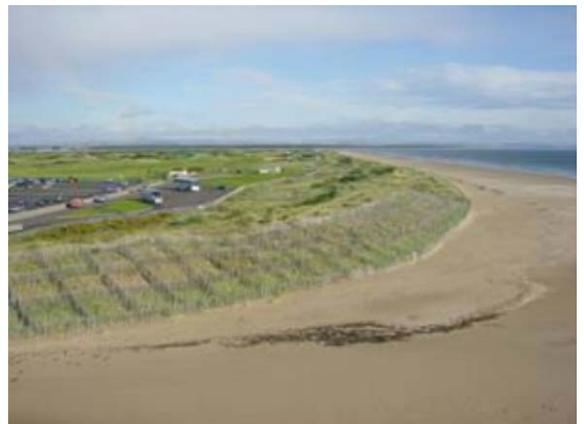
Sep 2011 –Lyme and marram grasses were transplanted from other areas of the dune

Further protection of the sand dunes and sand recharge area was achieved through a softer coastal engineering approach that included chestnut paling fences and marram and sea lyme grass planting. The grass acts as a natural dune stabiliser by trapping and binding sand with their roots and vegetative growth, which also reduces the loss of sand through wind erosion.
